**PHASE I  
ENVIRONMENTAL SITE ASSESSMENT  
FOR  
530 NORTH STATE ROAD  
BLOCK 4, LOT 65  
TOWN OF OSSINING  
WESTCHESTER COUNTY, NEW YORK**

August 24, 2007

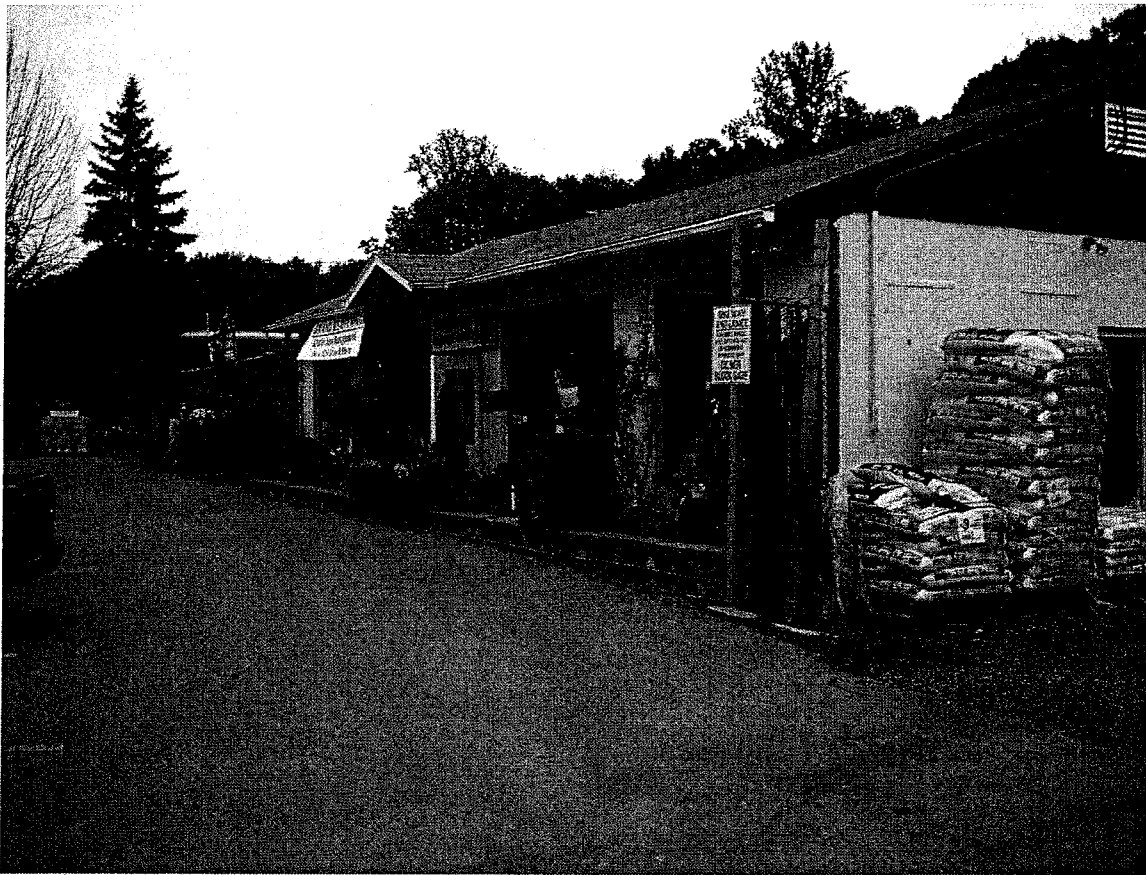
**Photo 1:** Representative view of the west side of the garden center.

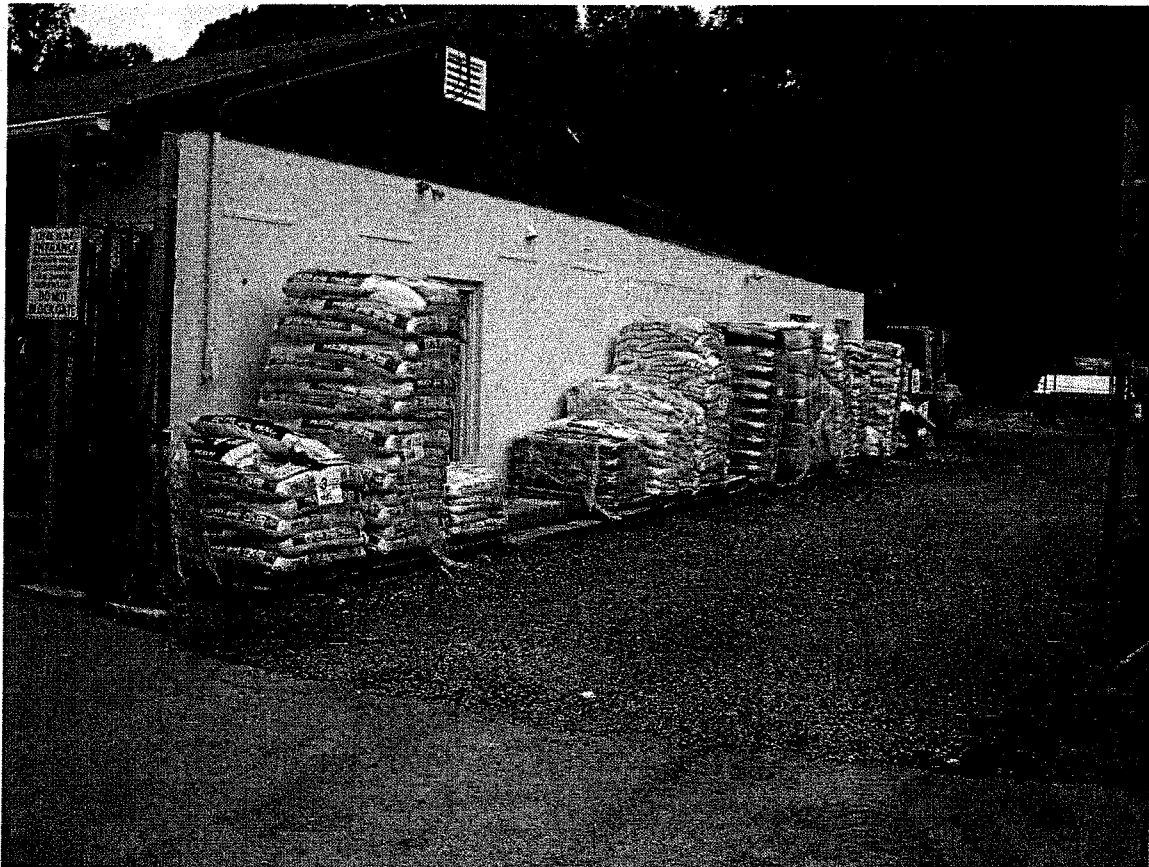
**Photo 2:** View of the southern side of the garden center.

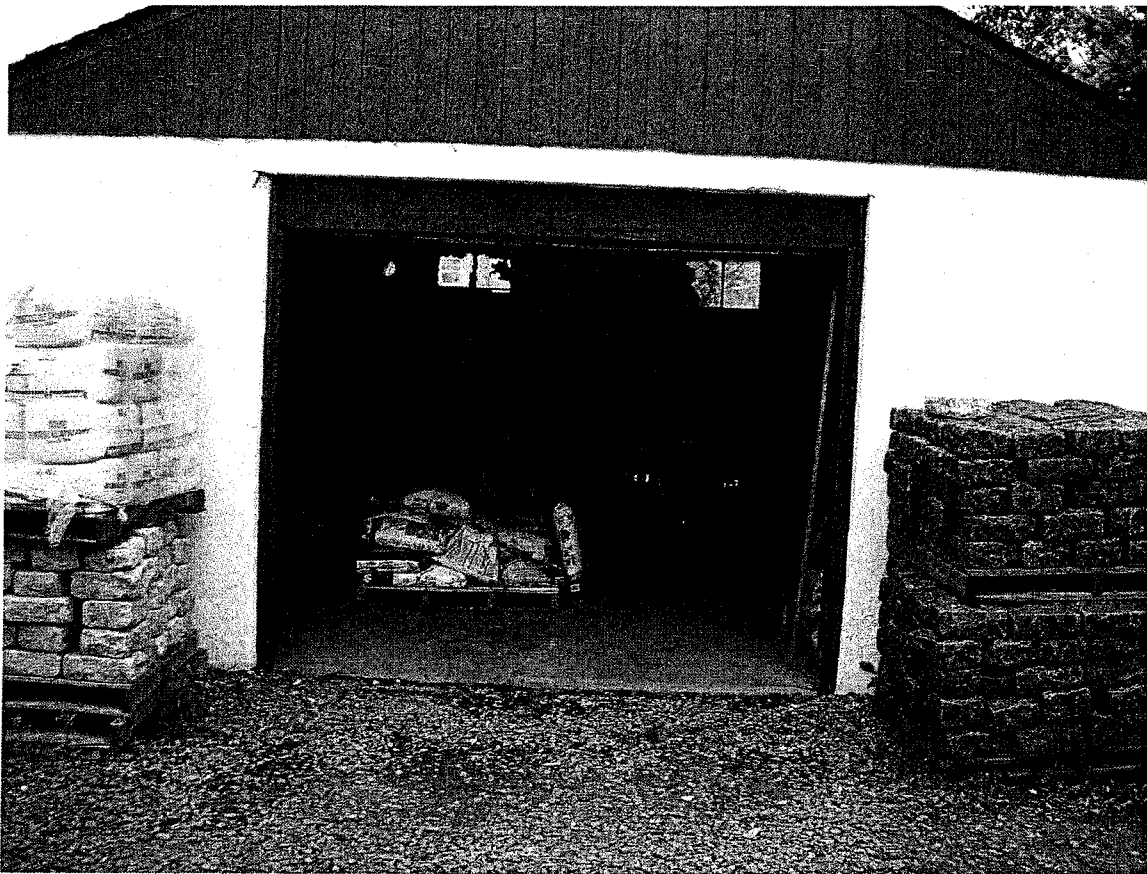
**Photo 3:** A view of the southwestern most shed.

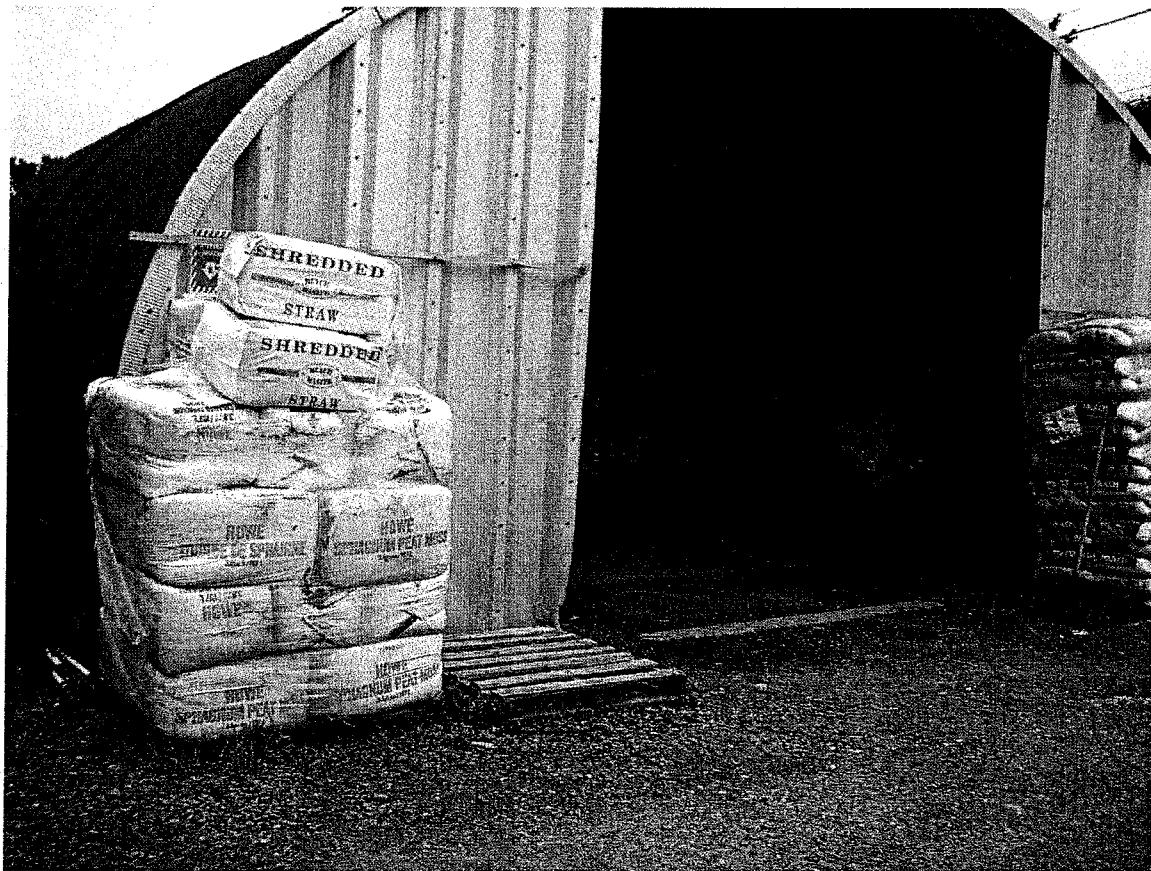
**Photo 4:** A view of the second shed, to the east of the above pictured shed.

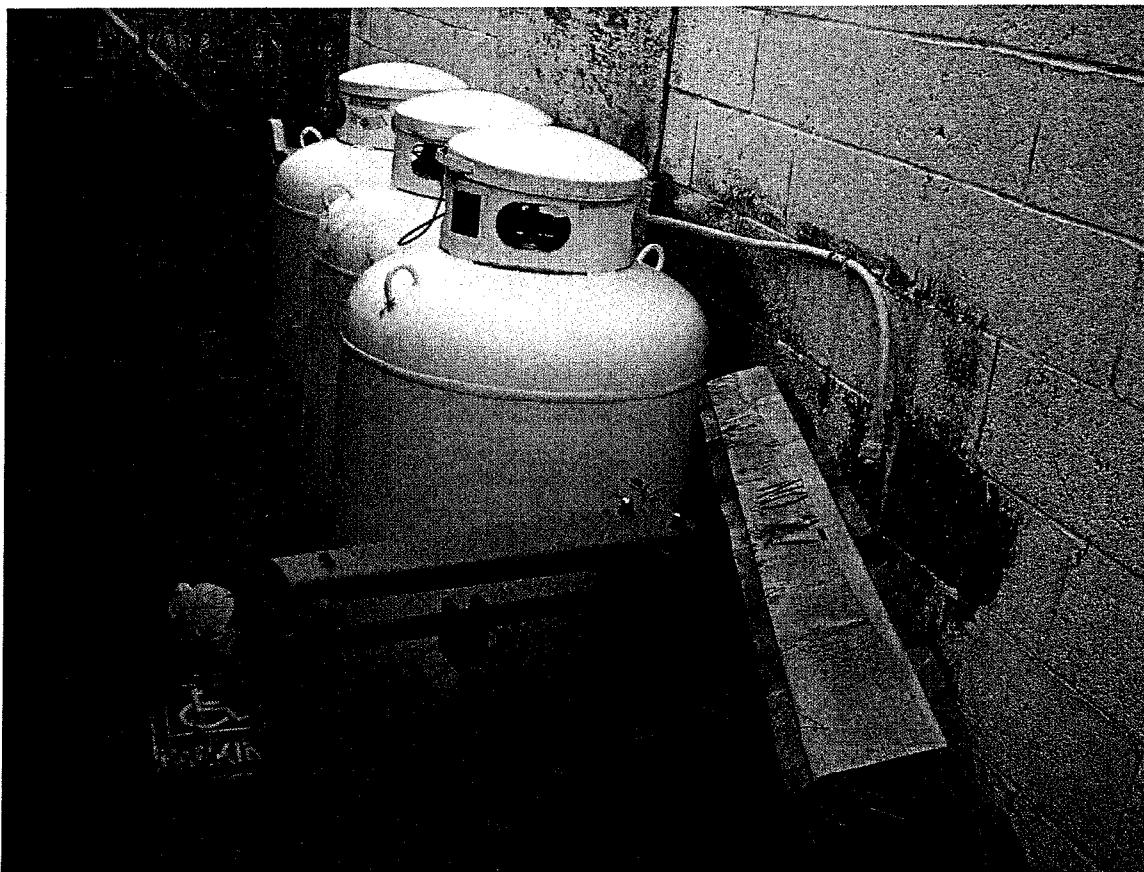
**Photo 5:** Propane tanks on the subject property, between the sheds.

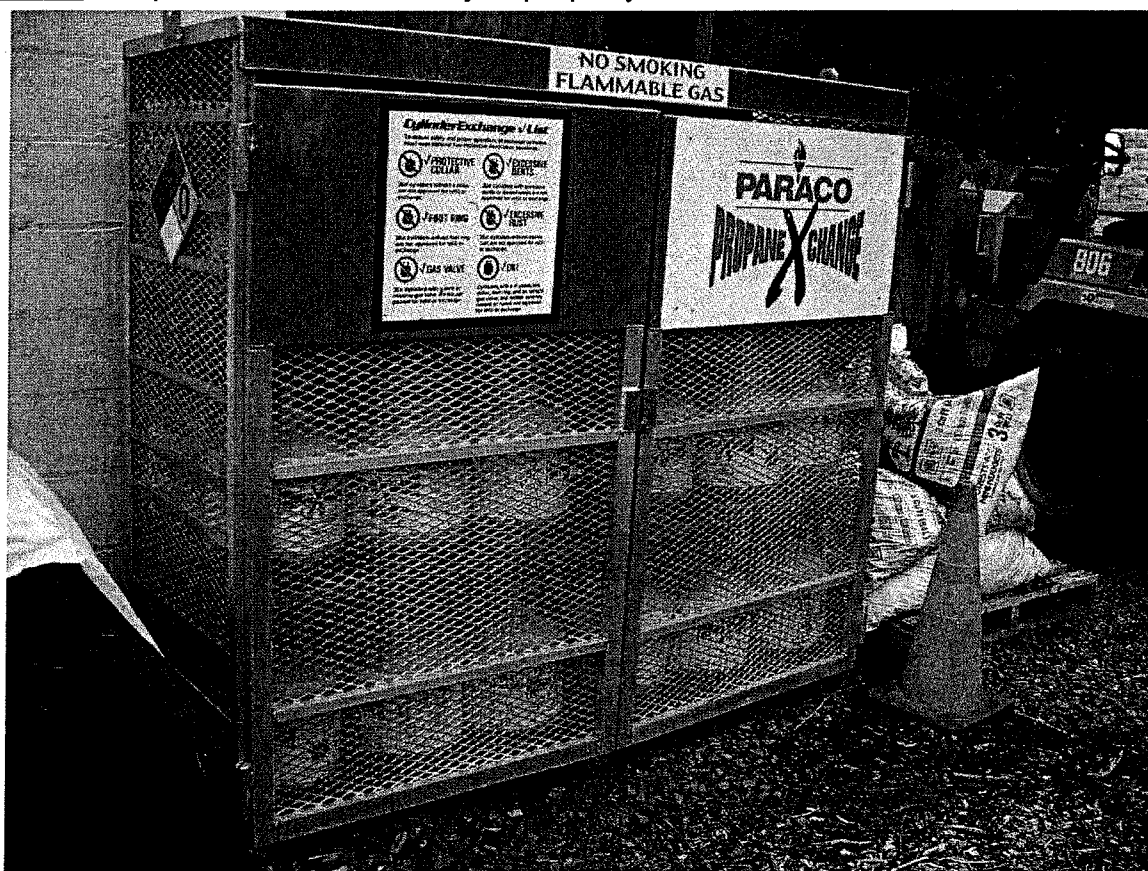
**Photo 6:** Small propane tank storage area.

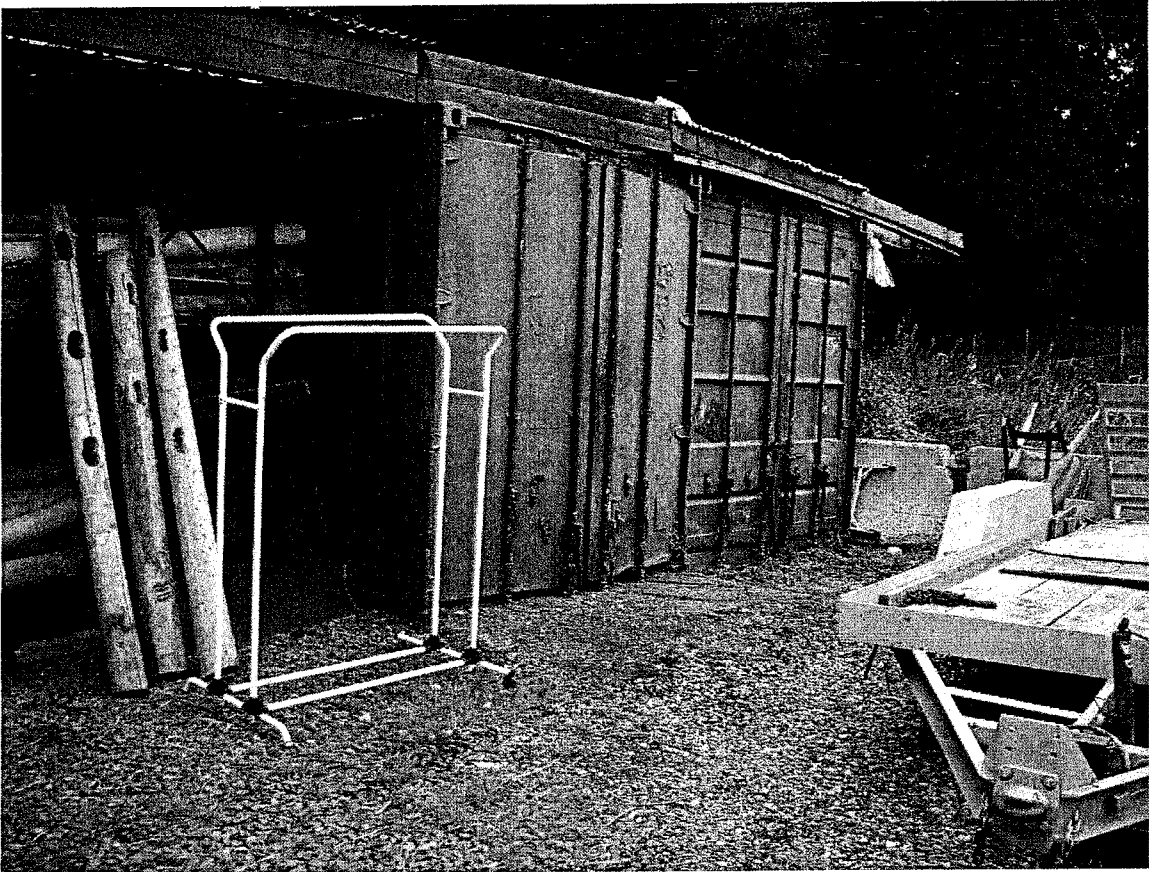
**Photo 7:** Storage containers on the southeast portion of the property.

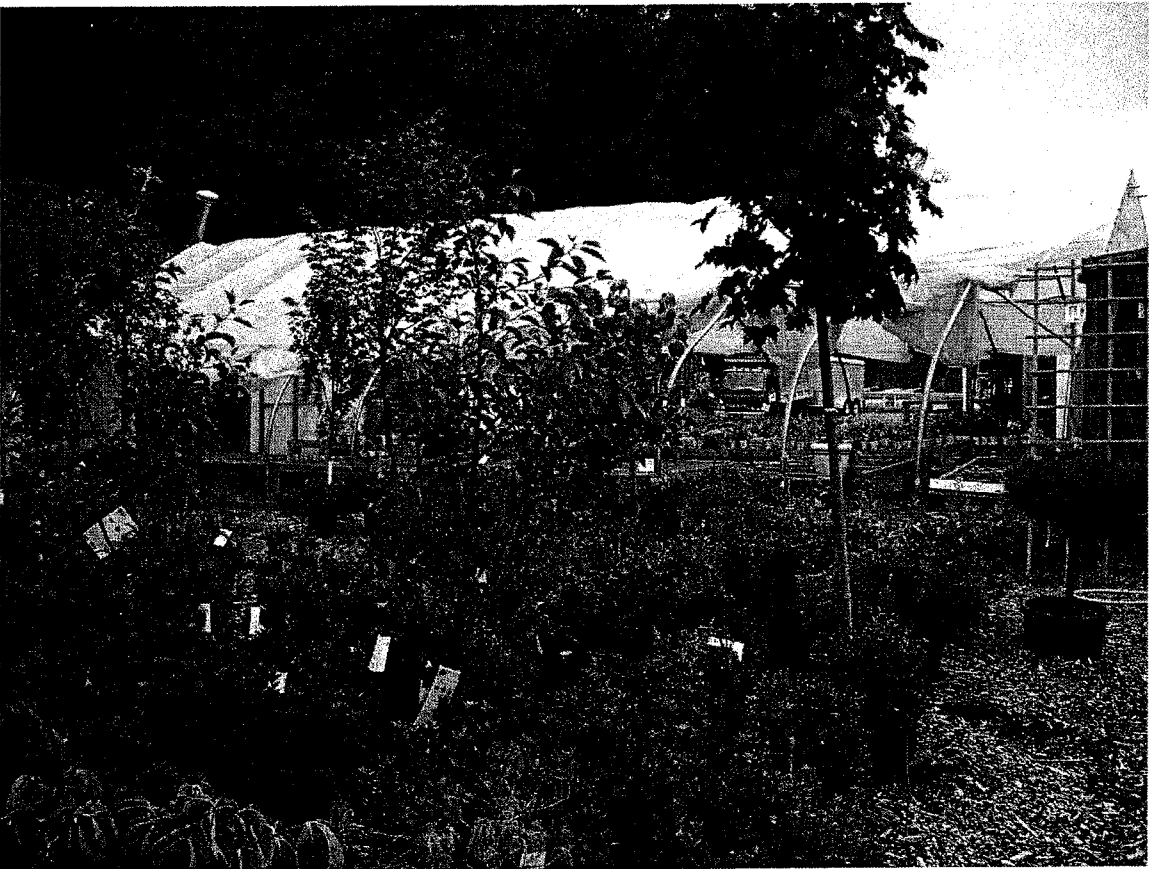
**Photo 8:** View of trees and shrubs in the foreground, and the greenhouse in the background.

- **Current Operations** – Based on the presence of the existing garden center, including a greenhouse and other areas where plants, trees, shrubs etc. are grown/maintained, soil sampling should be conducted to evaluate potential impacts from possible pesticide usage.
- **Potential Former Dry Cleaner** – Given that no information was available regarding the former onsite laundering companies and whether dry cleaning occurred onsite, soil borings should be conducted around the garden center building to evaluate potential impacts.
- **Hazardous Substances** – Prior to any future cessation of operations, any hazardous substances should be removed from the subject property and properly disposed of offsite.

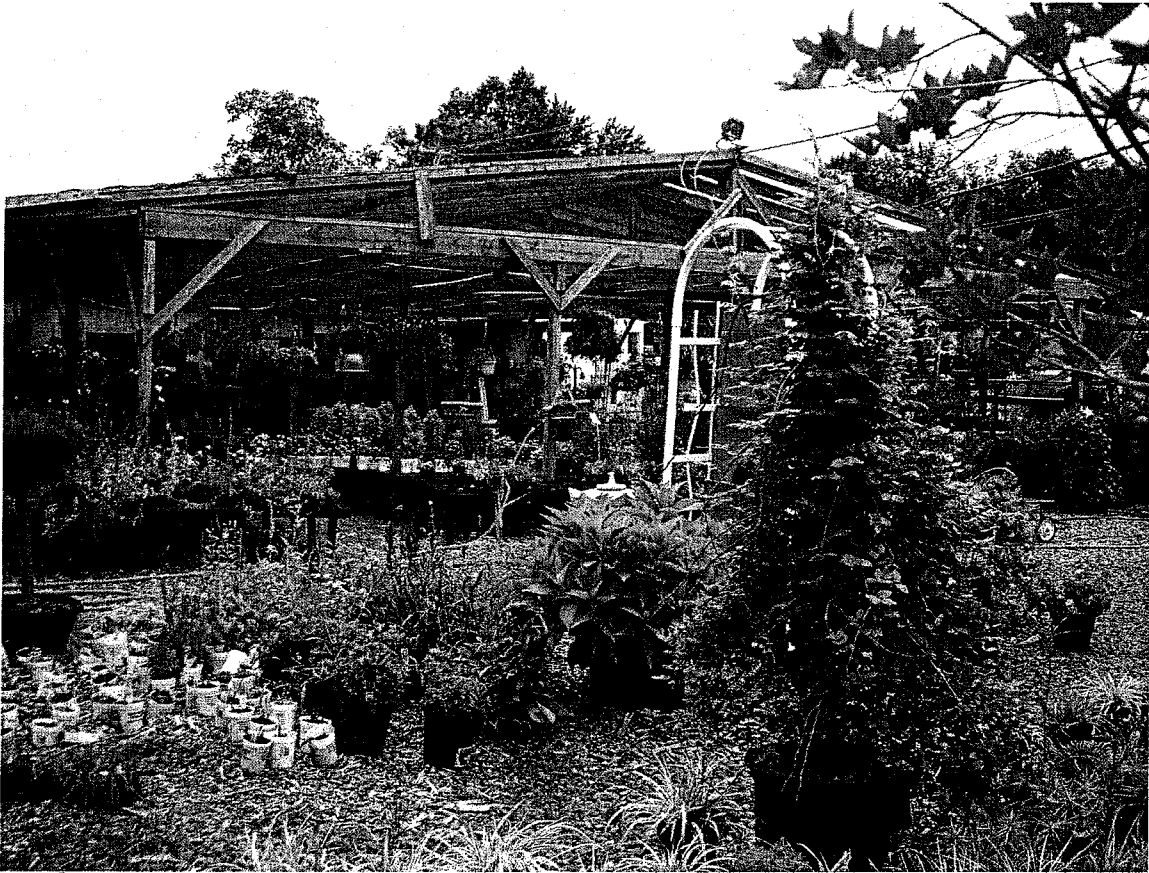
**Photo 9:** Wood framed open wall plant storage area.

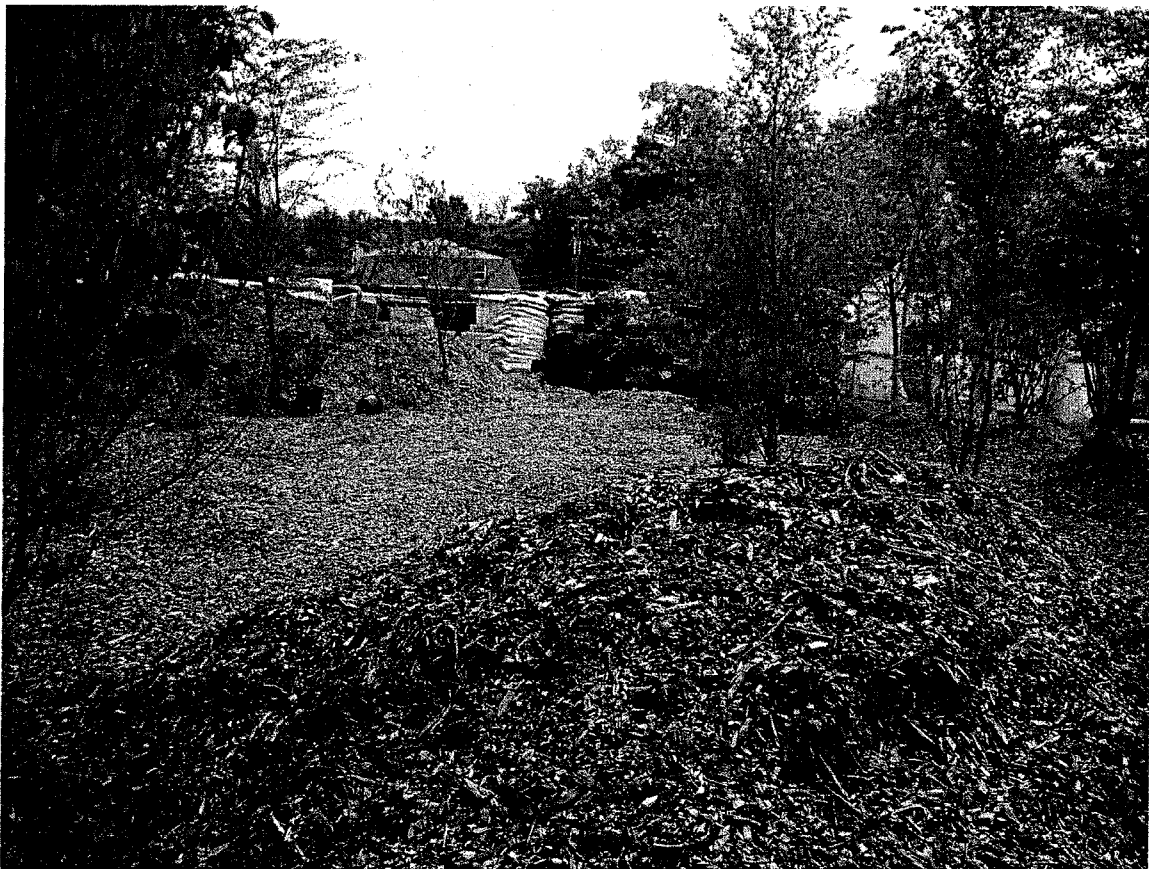
**Photo 10:** View of the mulch piles located on the subject property.

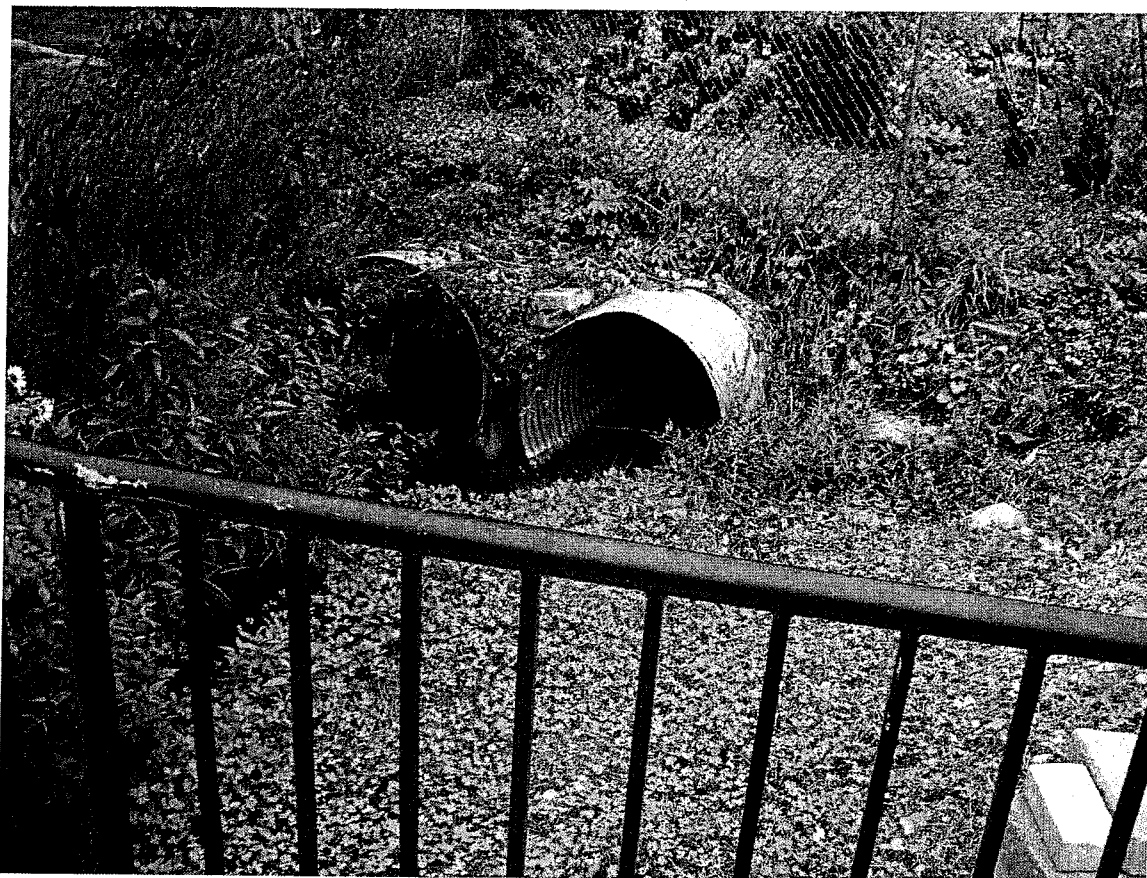
**Photo 11:** Culverted stream on the north side of the property.

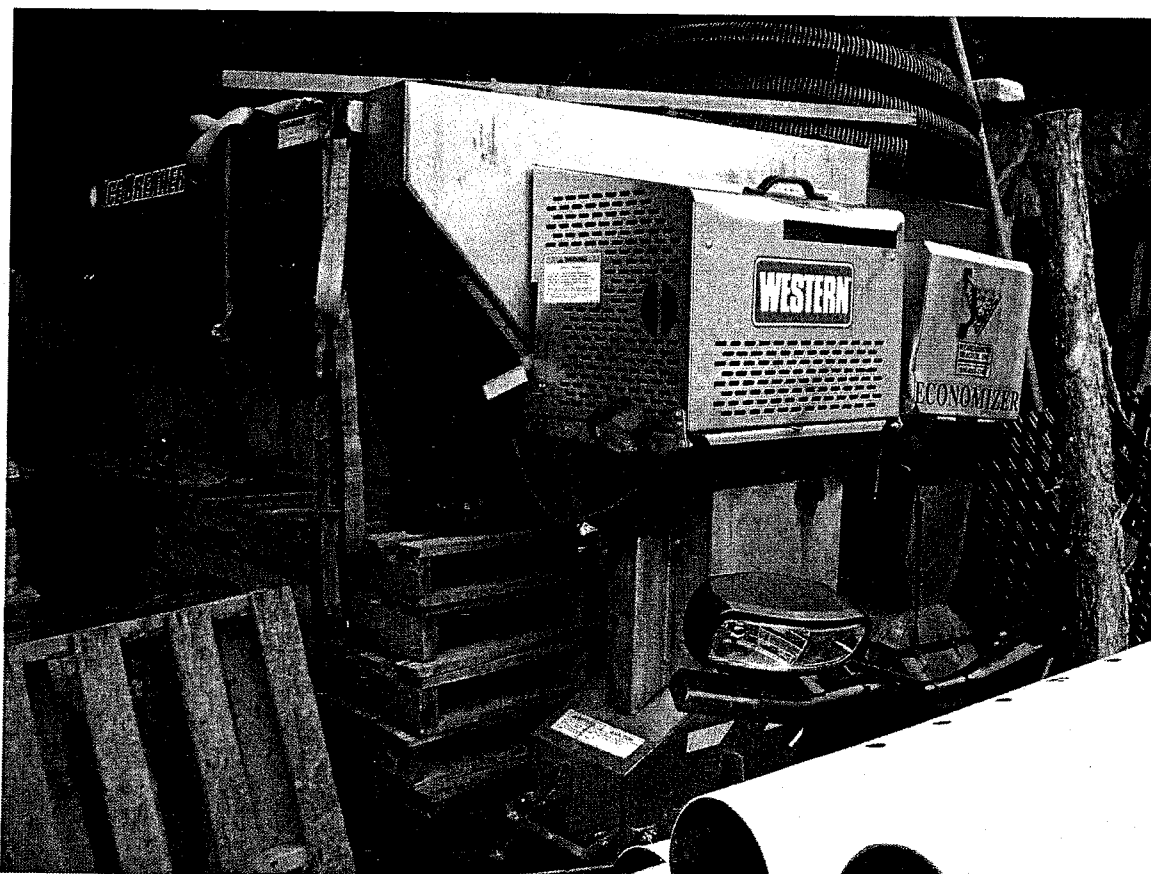
**Photo 12:** Machinery located along the eastern portion of the property.

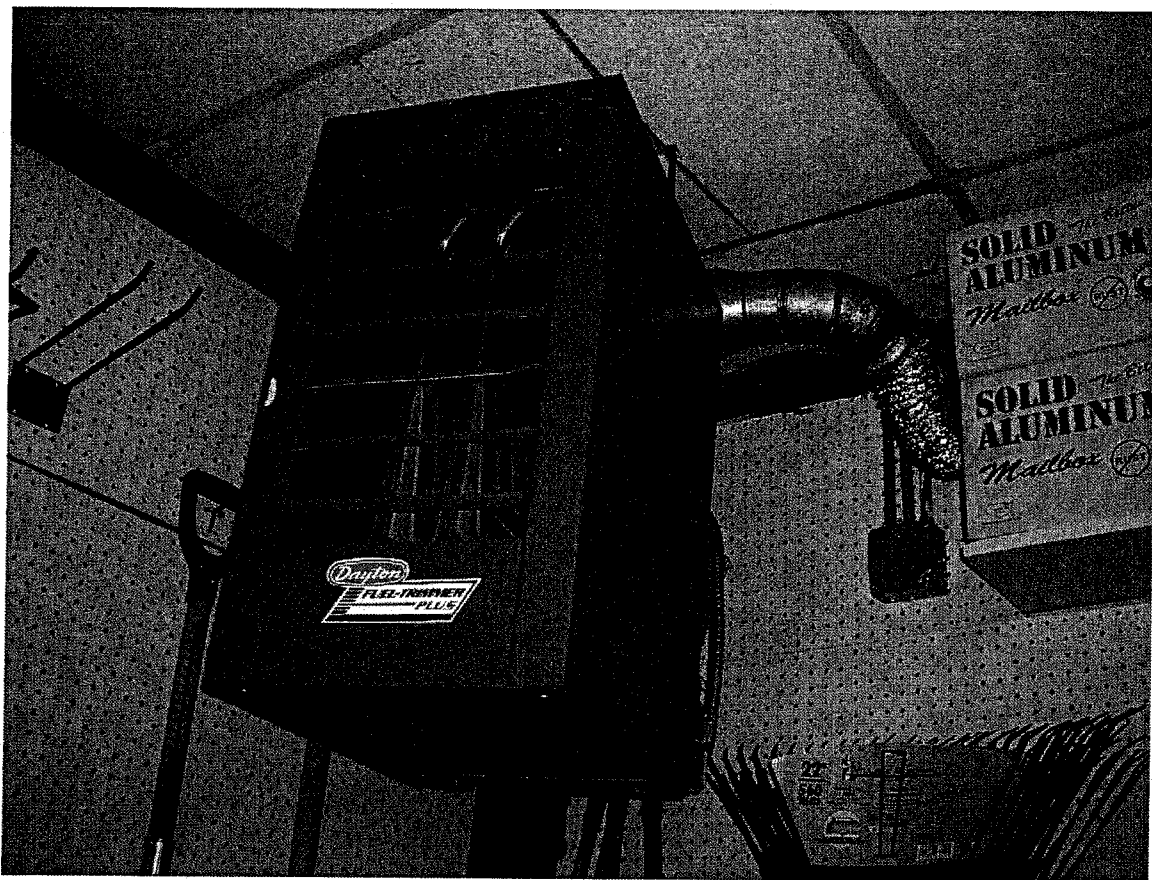
**Photo 13:** Roof mounted heating unit located within the garden center.
