**PHASE II ENVIRONMENTAL SITE ASSESSMENT**

530 North State Road  
Briarcliff Manor, Westchester County, New York

March 31, 2008

**DT CONSULTING SERVICES, INC.**  
1291 Old Post Road  
Ulster Park, New York 12487  
(845) 658-3484 (phone) / (845) 658-3320 (fax)  
dtconsulting@hvc.rr.com

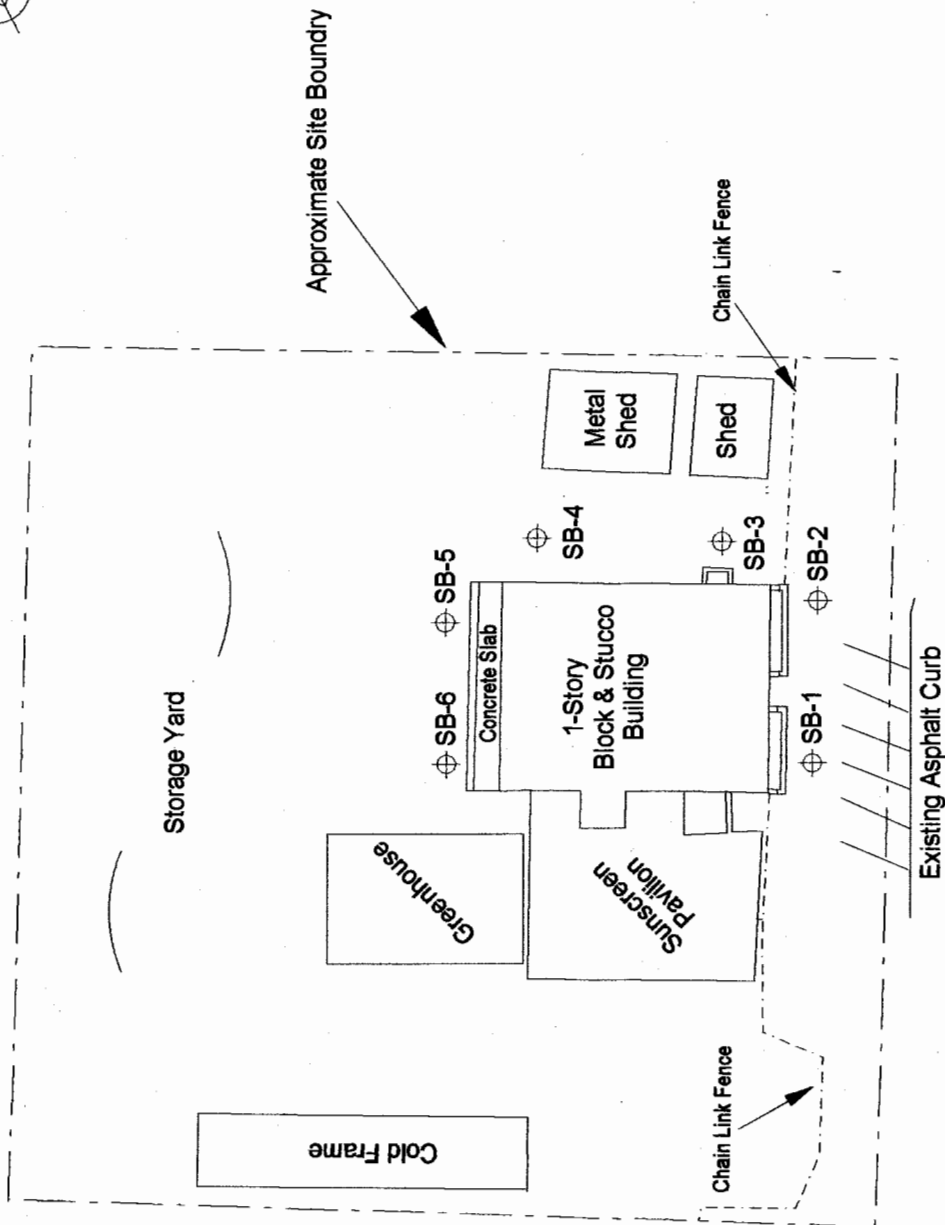
Scale: Approx. 1:40    Drawn By: DT    Spill No: N/A    Fig.#: 2

⊕ SB-1 = Soil Boring Location

Title: Site (base) Map

The location of soil borings SB-1 to SB-6 are identified in **Figure 2**.

Soil samples were collected for laboratory analysis from the bottom two (2) feet of each borehole. Based on field screening and PID readings, soil samples submitted for analyses were composited as follows (see Figure 2 for locations):
