BIOLOGICAL EVALUATION AND IMPACT ASSESSMENT

**530 NORTH STATE ROAD
BRIARCLIFF MANOR (TOWN OF OSSINING),
NY 10510**

MAY 22, 2018

**Wetland Biological Evaluation and Impact Assessment
530 North State Road
Briarcliff Manor (Town of Ossining), NY**

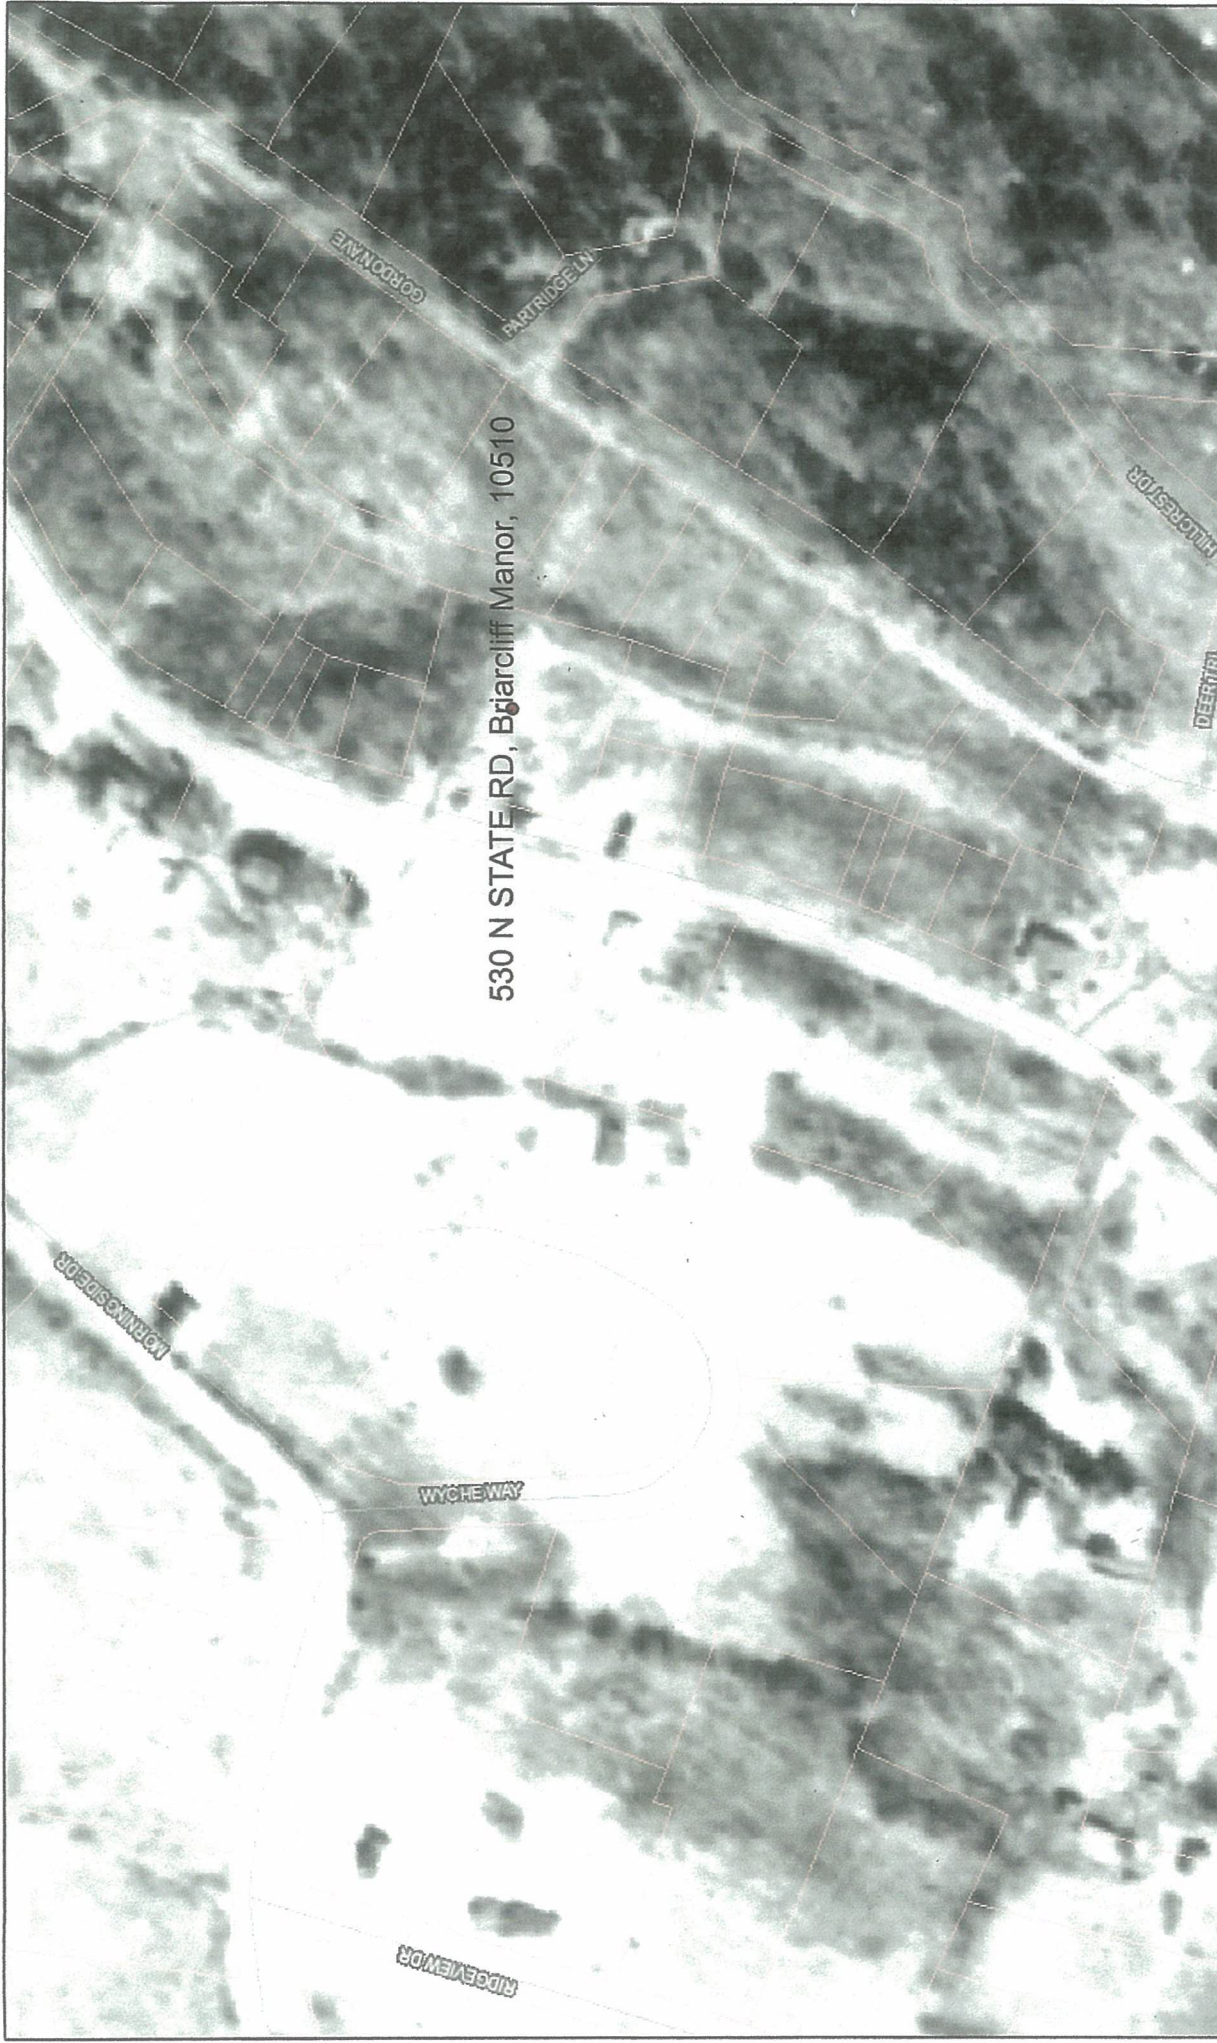
FIGURE A-1 1947

The first photo available, the 1947 (Fig. A-1) aerial demonstrates that the site and the surrounding properties were reverting agricultural lands. While North State Road itself is present, the parcels fronting on the road are almost all vacant. The lands to the west of what is now N State Road are maintained as open agricultural land, most likely and as grazing lands for cows. Significantly, the lands fronting on N State Road exhibit a pattern of old field vegetation establishment. This is due at least to a partial suspension of agricultural activities. Mapping by the NRCS (then SCS) (Fig. 2) shows the soil type on these parcels then to be Leicester Silt Loam, a somewhat poorly or poorly drained soil. Typically, these lands, being wetter, did not allow early or late season grazing and thus became unprofitable and were abandoned allowing the lands to revert to forest. Surrounding land use to the east is dominated by large open agricultural parcels and to the west by forested lands. Although some residential and estate parcels are evident, the dominant surrounding land use is still agriculture.

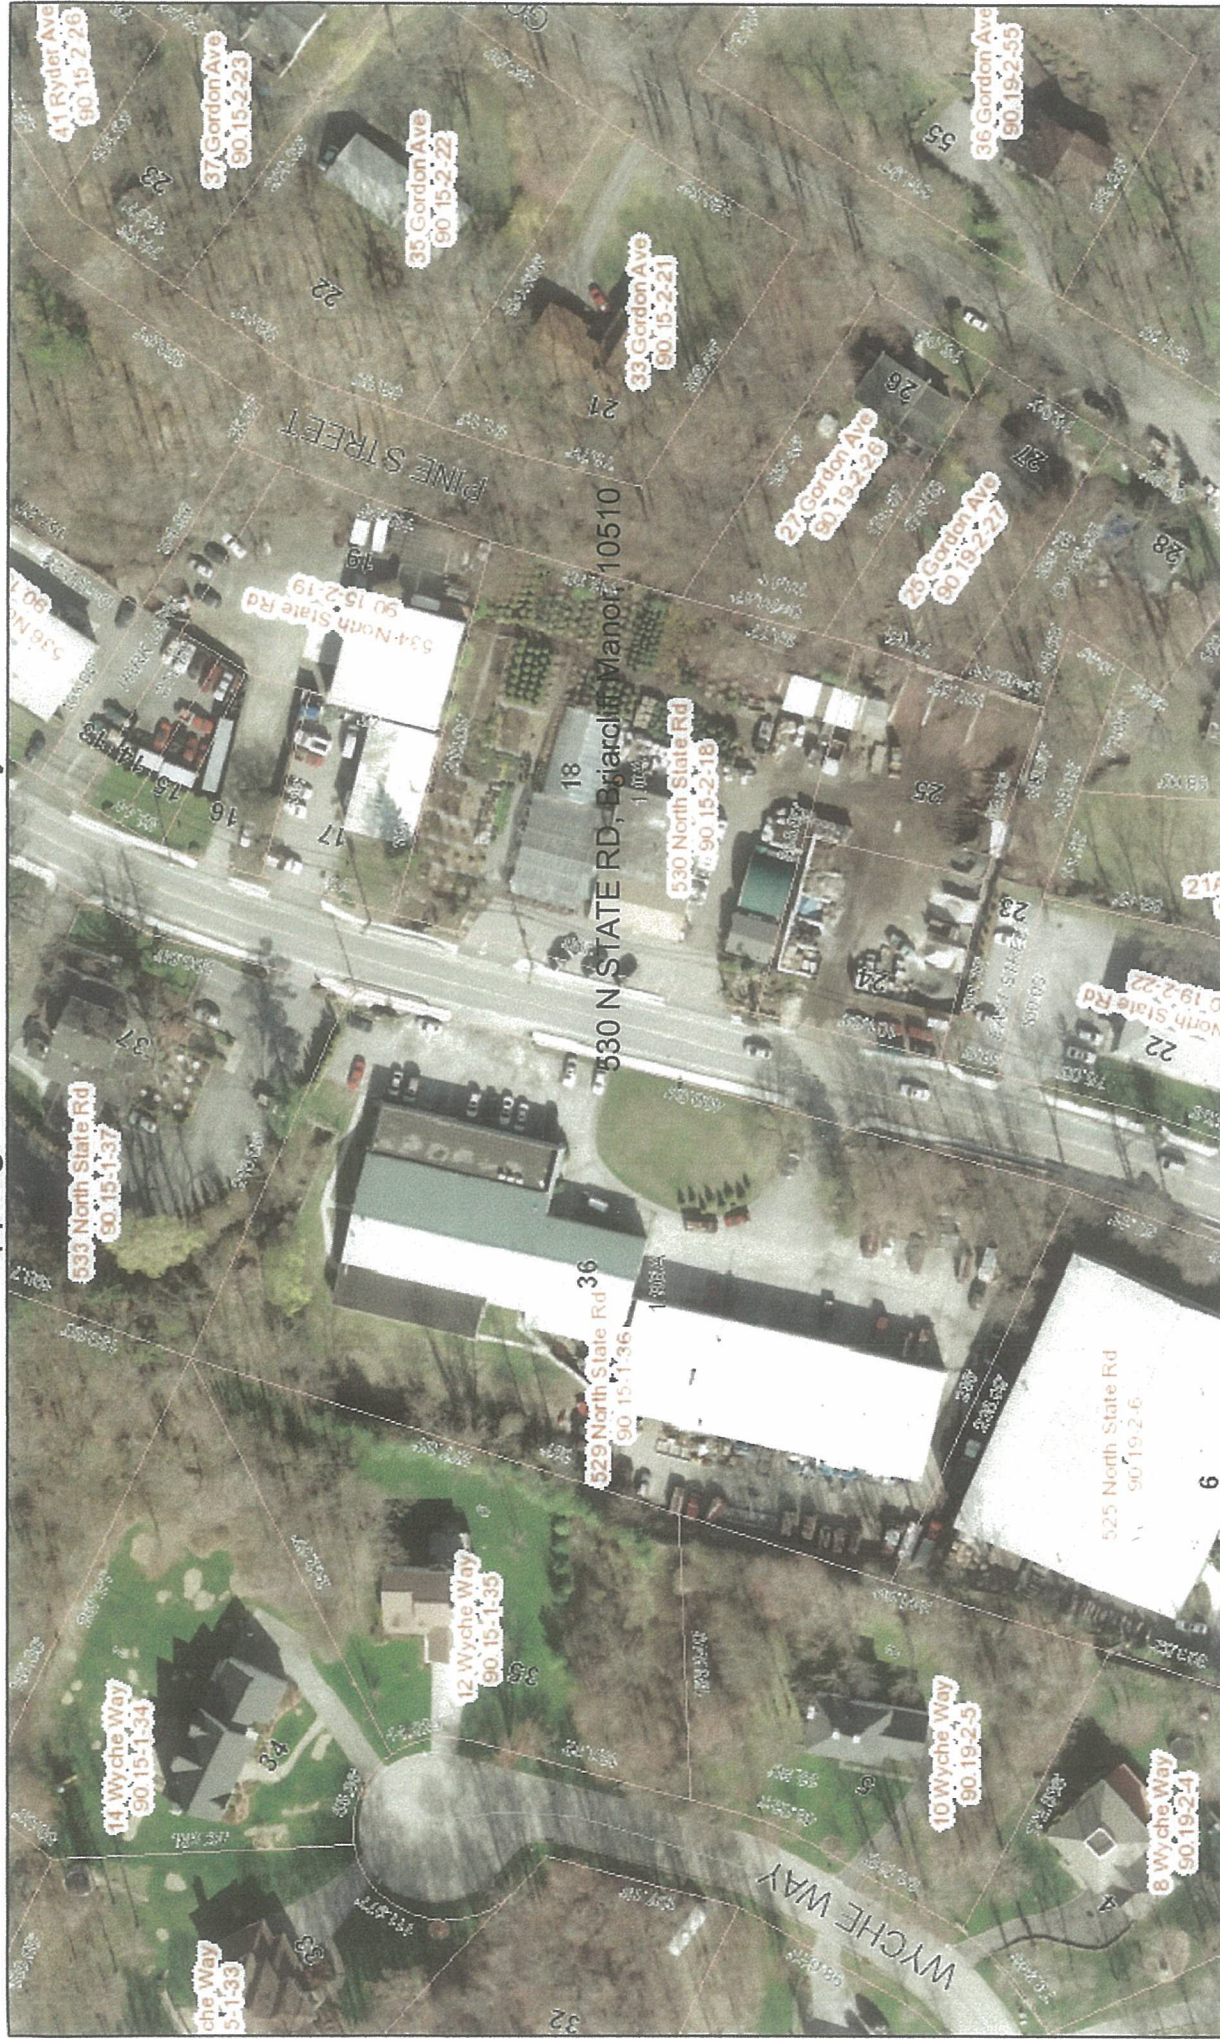
FIGURE A-3 2004

The 2004 (Fig. A-3) and 2013 (Fig. A-4) aerials show the continuing nature of change in the region. In 2004 the subject parcel was used as a retail garden center as evidenced by the neat rows of trees and shrubs stockpiled on the site. Also, significant is the development of the parcel abutting to the south. When this parcel was developed the wetland/watercourse complex to the rear of the site was filled and two 48 inch culverts were installed to convey stormwater flows, this is similar to the fate of the watercourse that once traversed the northern border of the subject site which is now culverted from the right-of-way of N State Road to the watercourse at the rear of the project site,

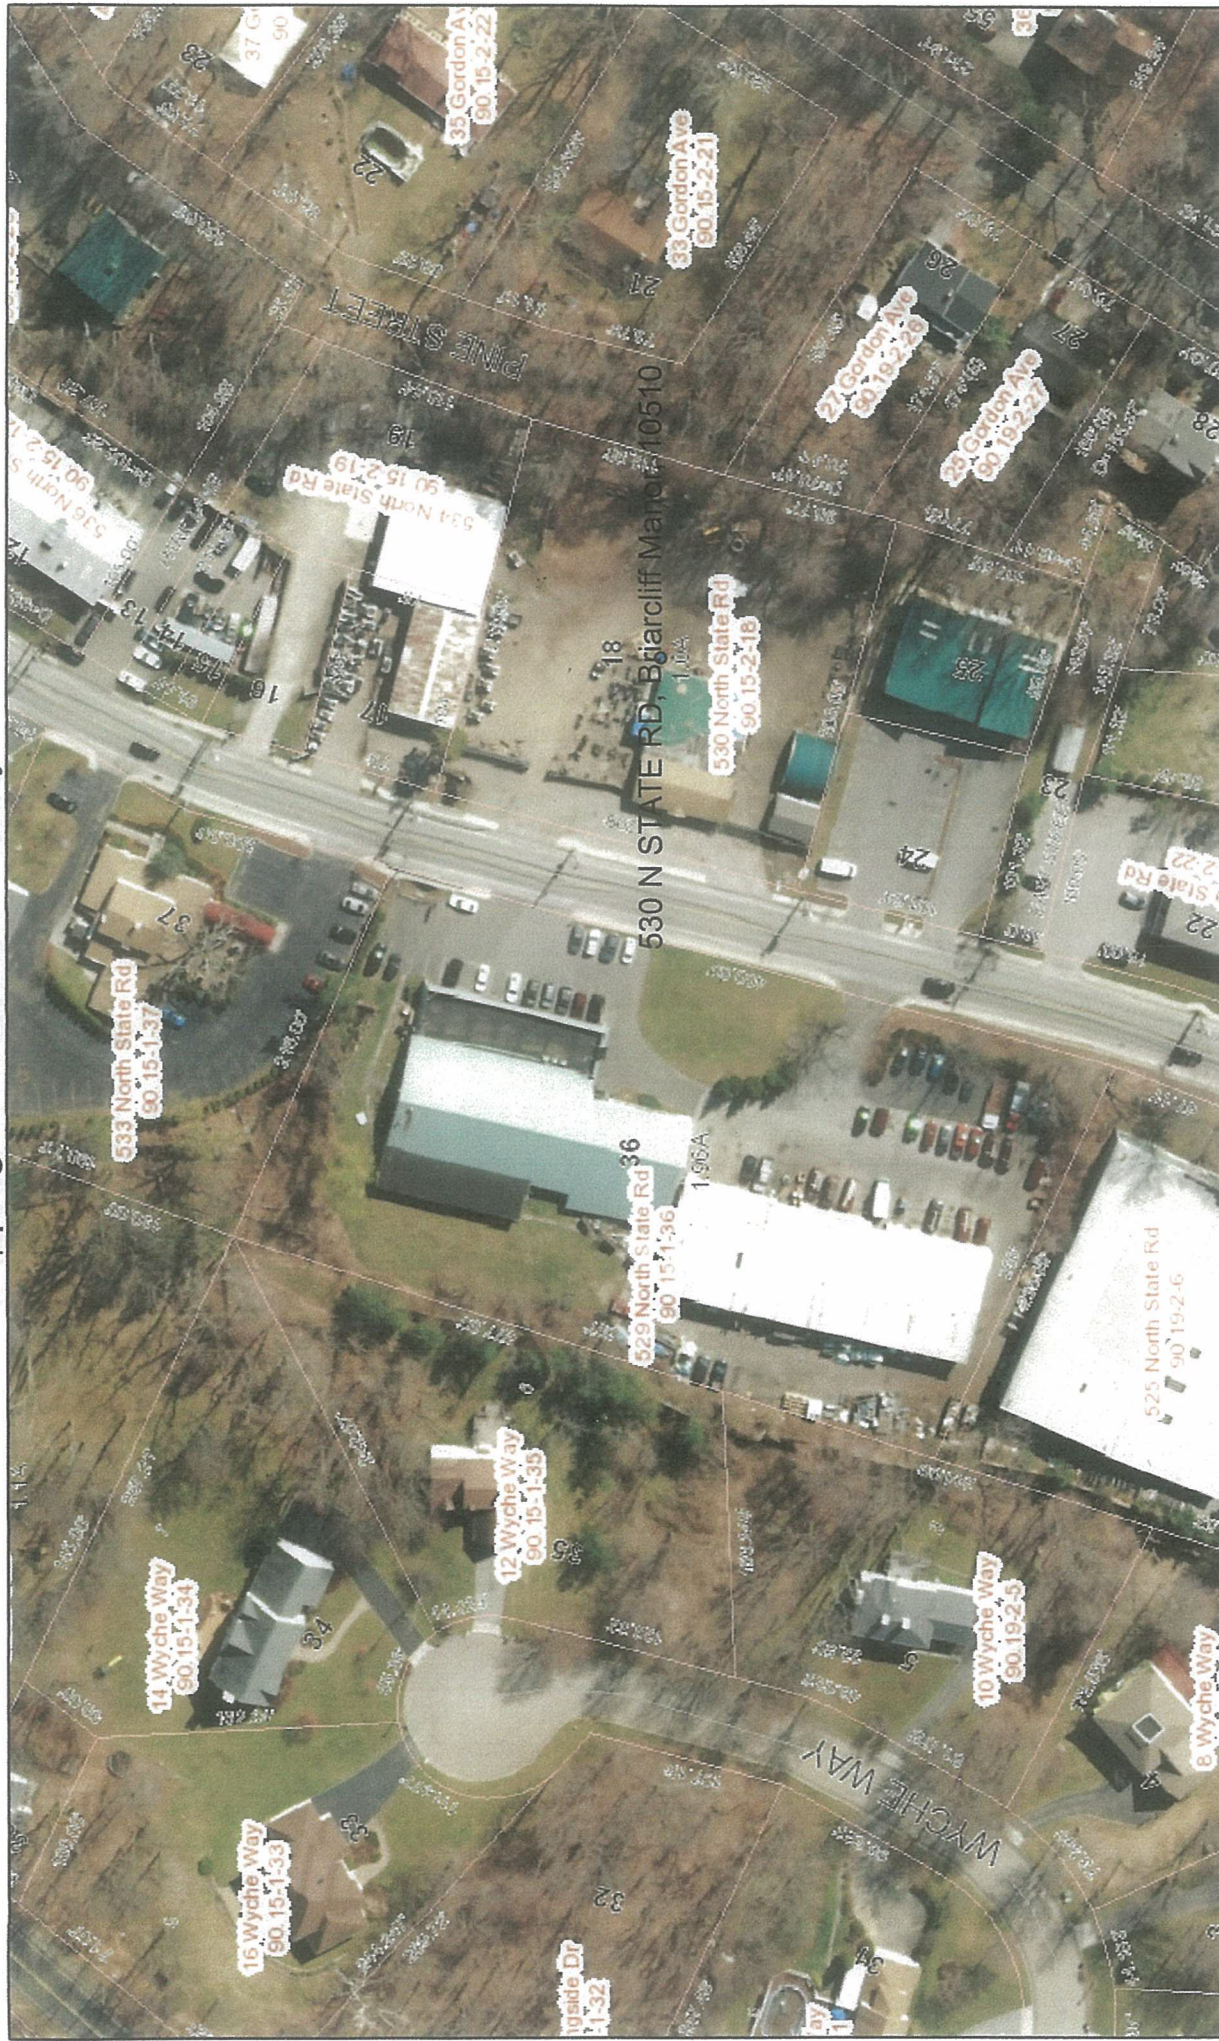
FIGURE A-4 2013

By 2013, the subject parcel was occupied by the present user – Bobcat of New York. The use is ancillary to the sales and service of heavy equipment on the neighboring property to the north.
