**APPENDIX D**  
**PHASE 1 ESA 2006,**  
**PHASE 1 ESA 2017**

**ENVIRONMENTAL SITE ASSESSMENT**

**Stony Lodge Hospital**  
40 Croton Dam Road  
Block 13, Lot 2  
Town of Ossining  
Westchester County, New York

**FIGURE 1: SITE LOCATION MAP**  
Project No. 17-185637.1

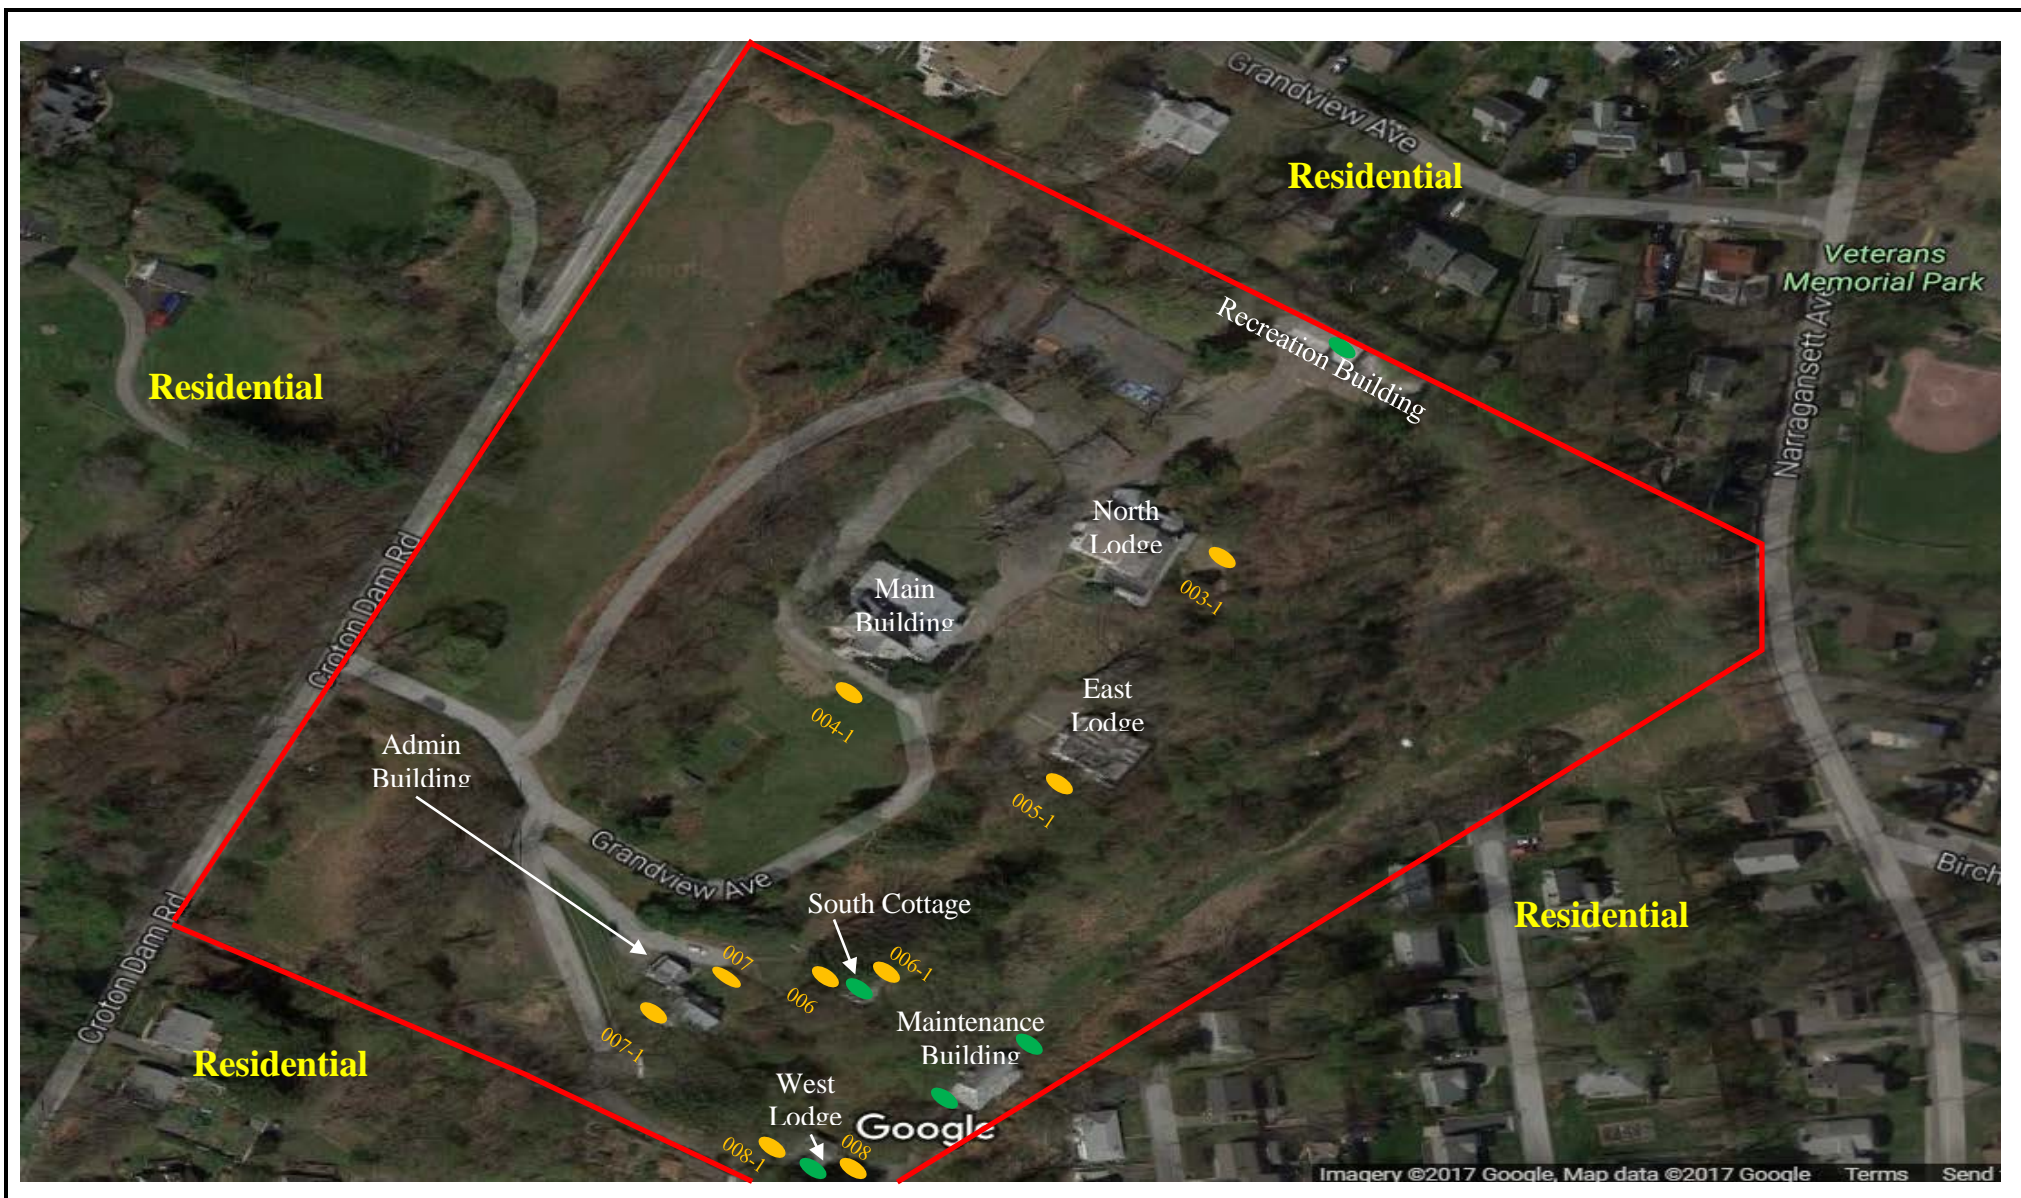
**FIGURE 2: SITE PLAN**  
Project No. 17-185637.1

**GROUNDWATER  
FLOW**

Approximate location of AST

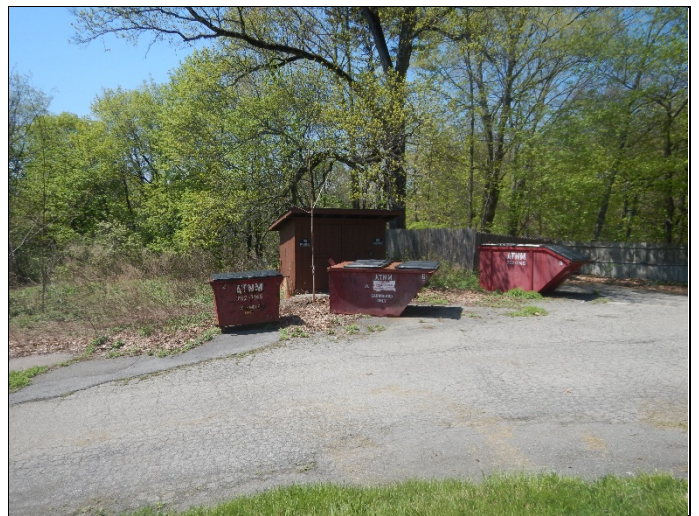
16. Photograph of dumpster storage area.

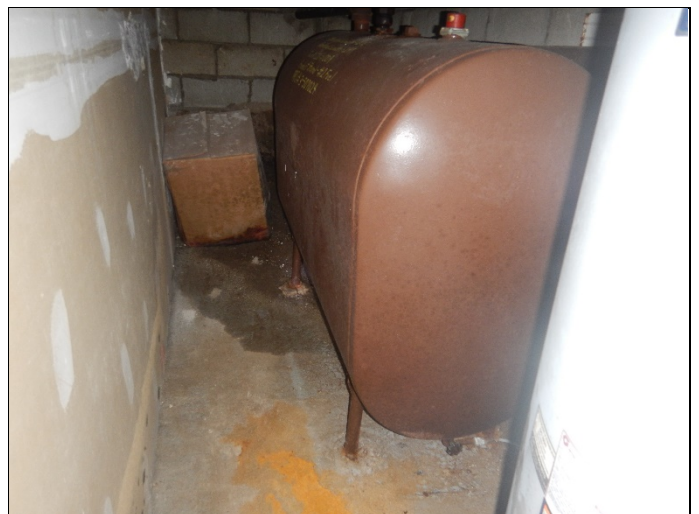
Transformers and other types of electrical equipment have historically utilized dielectric fluid containing polychlorinated biphenyl compounds (PCBs). SD observed one (1) pad mounted transformer near the main building on the subject property during the March 14, 2006 site inspection. The transformer appeared to be well maintained and in good condition. There was no evidence of stressed vegetation or staining visible on the ground surface in vicinity of the transformers that would be indicative of a past release of PCBs.

18. Photograph of AST in recreation building.

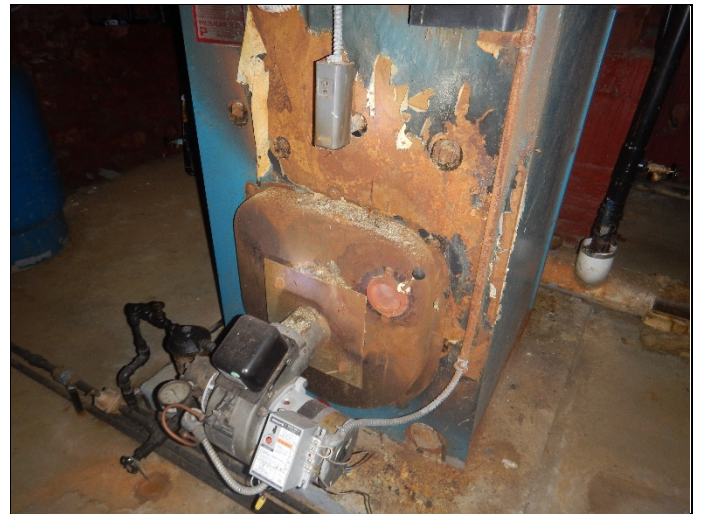
Boiler/furnace rooms were located in each building described in section 4.1, except for the garage and small storage sheds. The boiler rooms contained furnaces and hot water heaters. The furnaces were fueled by #2 heating oil while the hot water heaters were typically fueled with either propane or #2 heating oil. In each building, the boiler room floors were made of concrete and were of sound integrity with no indication of staining observed.

28. Photograph of oil-fired boiler.
