MEMORANDUM

To: Ms. Ingrid Richards, Chairperson
Town of Ossining Planning Board
From: Stephen W. Coleman
Re: **Artis Senior Living, LLC, 553 North State Road, Briarcliff Manor,
Town of Ossining - review of wetland delineation, application
materials and plans, potential wetland impacts and recommended
mitigation measures**
Date: July 7, 2015
cc: S. Donnelly, Supervisor, D.Stolman, FPCA

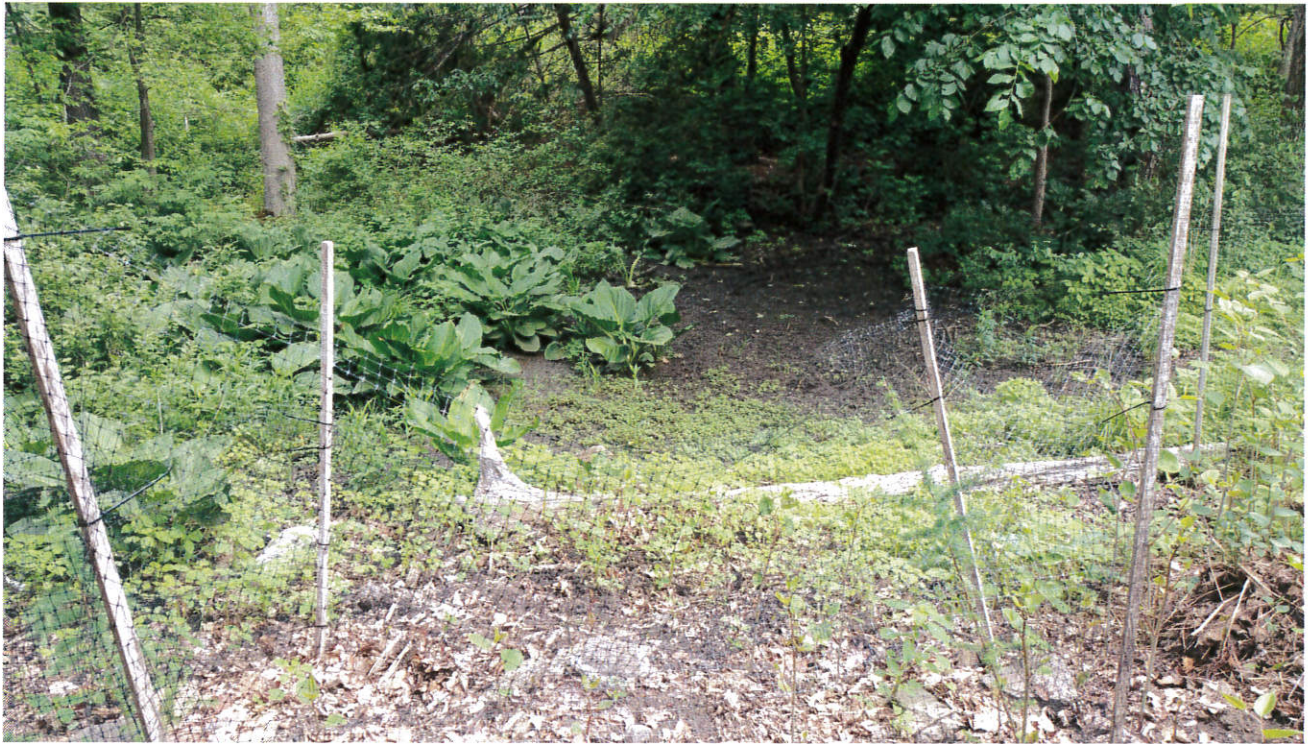
The off-site forested wetland is primarily intact and consists of typical wetland plant species. Around the edge of the wetland, several invasive plant species have become well established and show signs of encroachment within interior sections of the actual wetland. The most common invasive shrub at the edges of the wetland are multi-flora rose, Japanese stilt grass and Japanese barberry.

The primary function of the adjacent wetland and watercourse appear to be flood storage and stormwater conveyance. The adjacent forested wetland provides some habitat value for more common wildlife species, but due to the proximity of adjacent residential properties, the wetland is highly fragmented. Existing plant communities present on the subject parcel consist of remnants of second growth forest with the majority of trees removed and kept to perimeter areas of the property. The majority of the site has previously been converted to lawn and open areas. Extensive signs of prior commercial activities are evident throughout the parcel. Overall, the habitat quality of the existing open spaces has been compromised long ago from a history of commercial and residential uses on the property.

(Forested wetland immediately off-site and discharge into intermittent watercourse channel, watercourse to right side of property, Artis property on right side of photo)

- Although, the forested wetland is not regulated by Chapter 105, it is recommended that the wetland be considered as part of the project's buffer mitigation measures.

- The applicant should seek permission from the adjoining landowners along the rear property line to remove invasive plant species that are located along the edge of the wetland. Once removed, the area could be re-planted with native shrubs and ground covers to help protect and improve the edge habitat along the forested wetland. This unregulated wetland area does provide hydrological support for the intermittent watercourse, and removal of invasives and re-planting with native species would help off-set the permanent loss of the 50 foot buffer area that is located on the subject parcel.

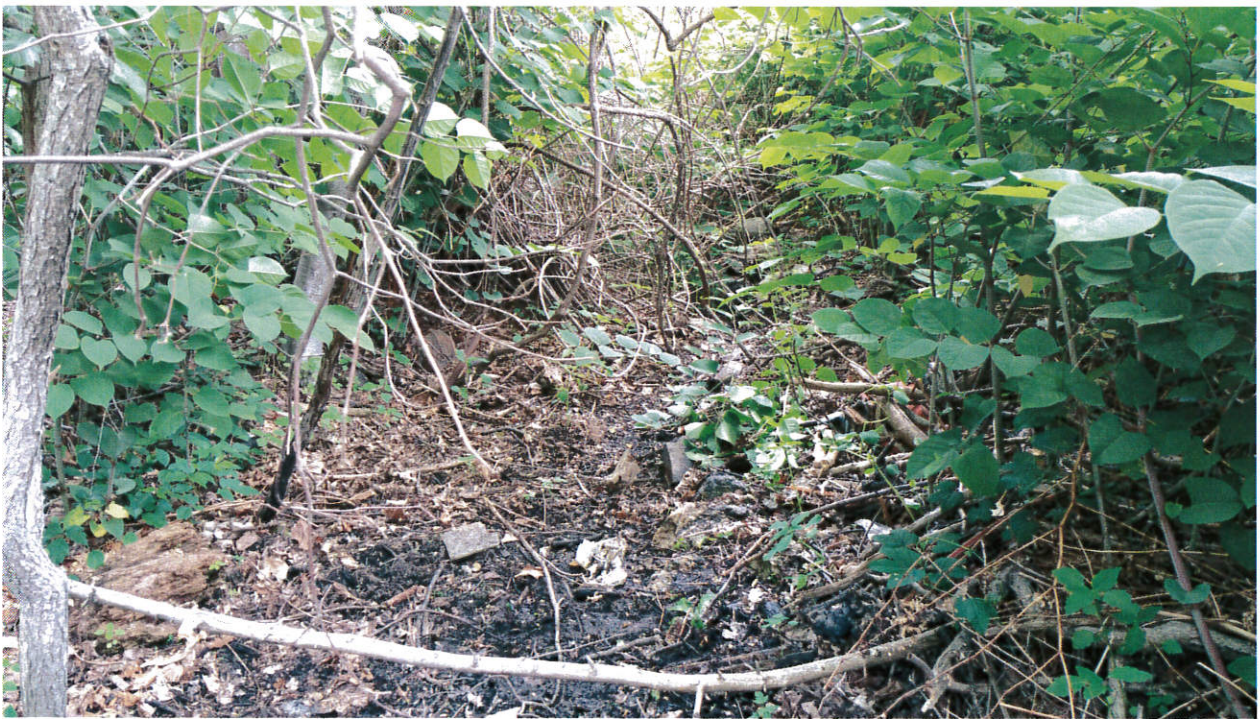
The entire subject parcel shows extensive signs of prior land disturbance. Existing topography and contours have been altered as a result of land use practices. The rear portion of the property along the property line shows extensive soil disturbance with extensive grading and berming of soils along the rear property line. The berm appears to have been created to re-direct surface flows from entering the main portion of the parcel. A linear channel has formed from discharge from the wetland and is located at the bottom of the berm and runs parallel to the rear property line. Surface water within the channel travels in an easterly direction and eventually discharges into the existing 15 inch concrete culvert in the northeastern corner.

The watercourse channel is located at the base of the existing berm. The entire berm surface is dominated by invasive plant species consisting of Japanese Knotweed and Multi-flora rose. The intermittent watercourse channel exhibits sufficient flow characteristics as evidenced by clear scouring of the bottom of the channel, the lack of vegetative growth within the bottom, and defined banks on both sides of the channel. The flatness of the bottom of the channel allows water to accumulate and remain saturated long after storm events.

(Photo showing watercourse channel as it runs parallel to the rear property line, located on Artis property, Japanese knotweed along right side of watercourse channel at the base of existing berm)

- The entire berm along the rear property line should be cleared of all invasive plant materials, and the slope re-stabilized. The soils on the berm should be treated to assist with elimination of invasive plant seed stock and roots that are within the berm. After treatment, new soil should be brought in to cap the berm and the entire surface area re-planted with a combination of native shrubs and ground covers. The re-creation of a naturally vegetated berm along the edge of the wetland would create more functional habitat and serve to minimize the spread of invasive plant species.

- The entire watercourse channel including the bottom should be stabilized with stone rip-rap along the banks. This would reduce the amount of sediment transport and keep the banks of the watercourse channel from eroding.

- Where the channel meets the location of the existing 15 inch culvert, the watercourse channel widens out. This area should be converted to a forebay area that would store water for longer periods, allow natural infiltration and during larger storm events, help to regulate water flows leaving the site. The bottom of the forebay and side slopes should also be lined with stone to create a permanent catchment area that could be periodically cleaned out of accumulated sediments and debris.

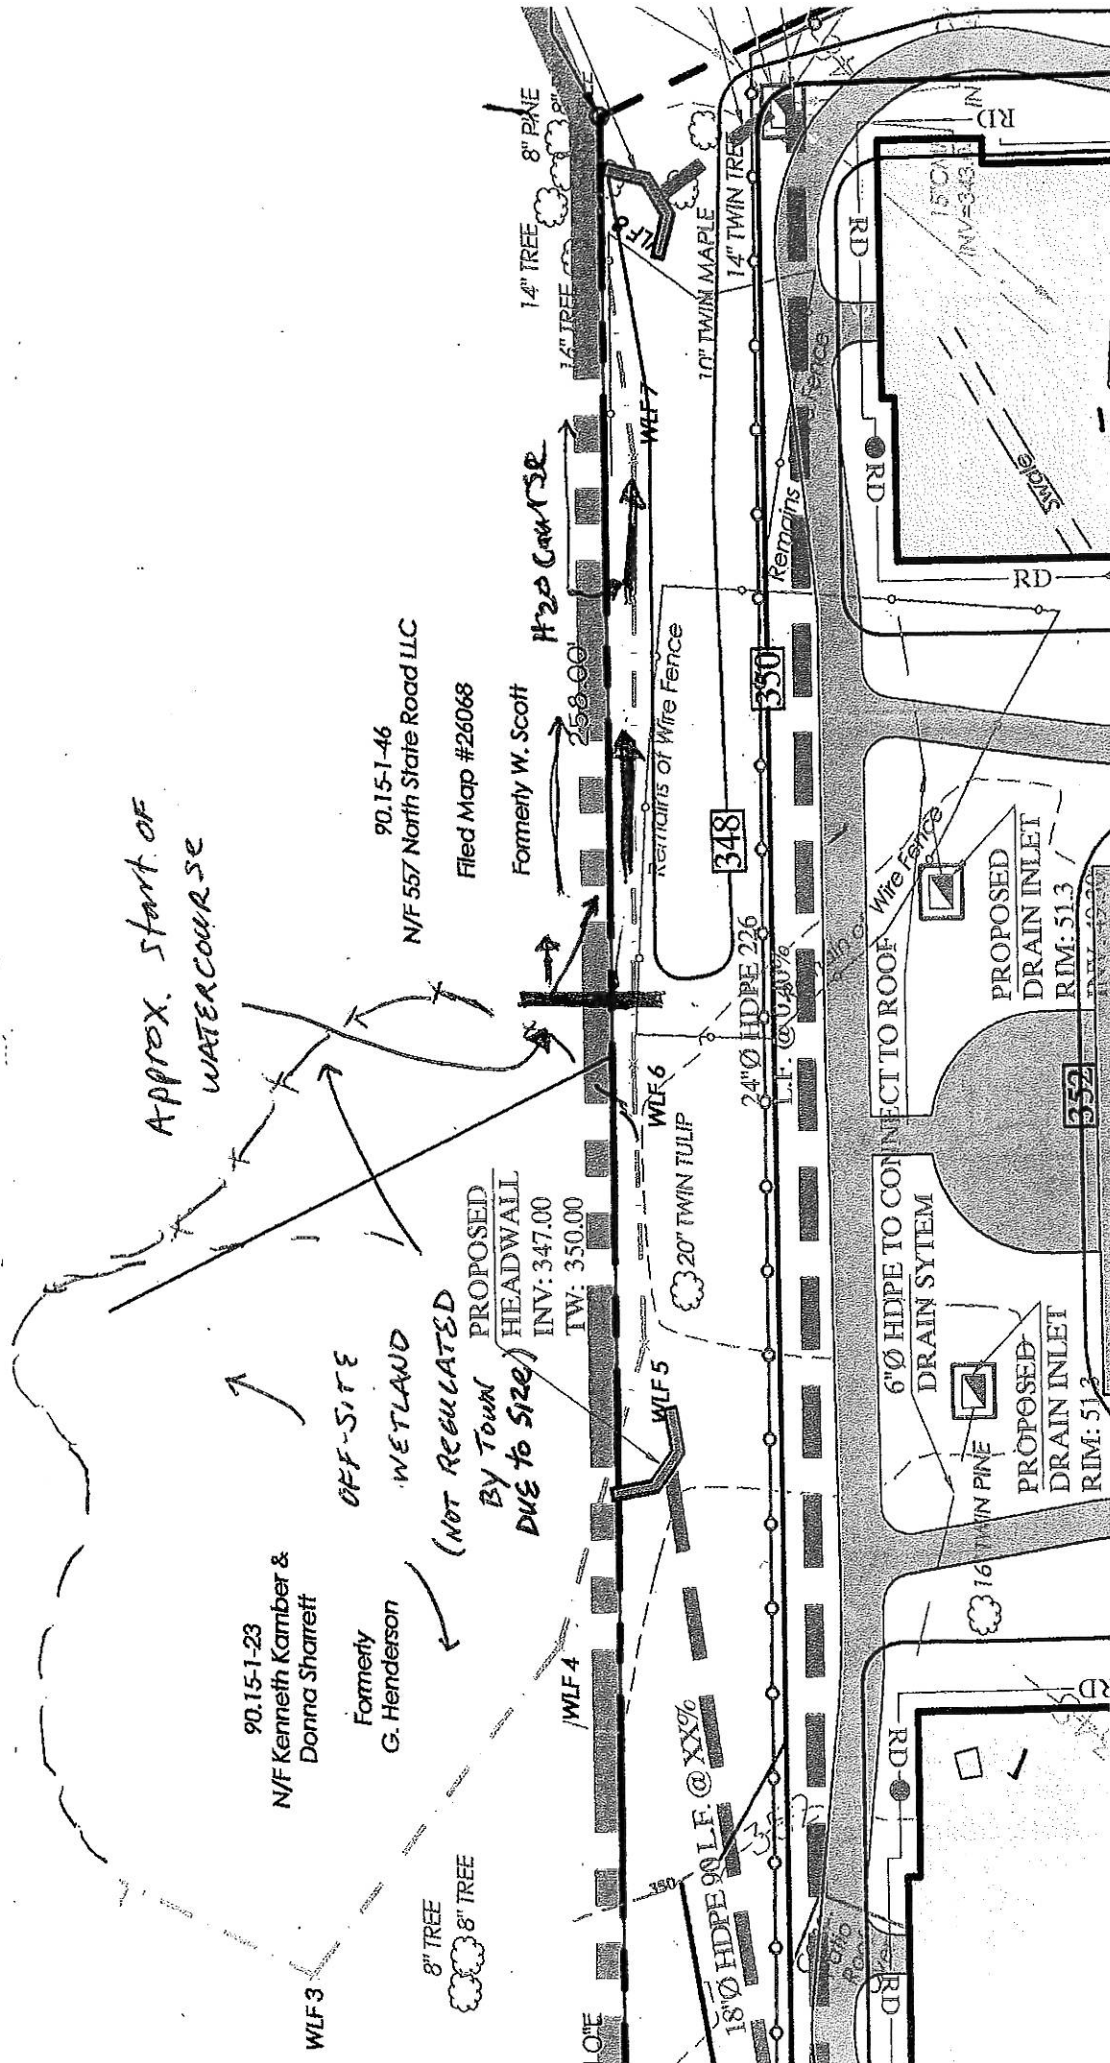
ARTIS - Field sketch plan -

The presence of the intermittent watercourse that discharges from the adjoining wetland meets the criteria outlined in Chapter 105 of the Town Code of the Town of Ossining to be classified as a wetland. The intermittent watercourse channel continues along the property line and discharges into the existing culvert in the northeastern corner of the parcel. The watercourse where it discharges from the forested wetland would be subject to a 50 foot buffer (see attached field sketch that shows the approximate location of the intermittent watercourse).

FIELD SHEET FROM
approx location of wetland AND watercourse areas

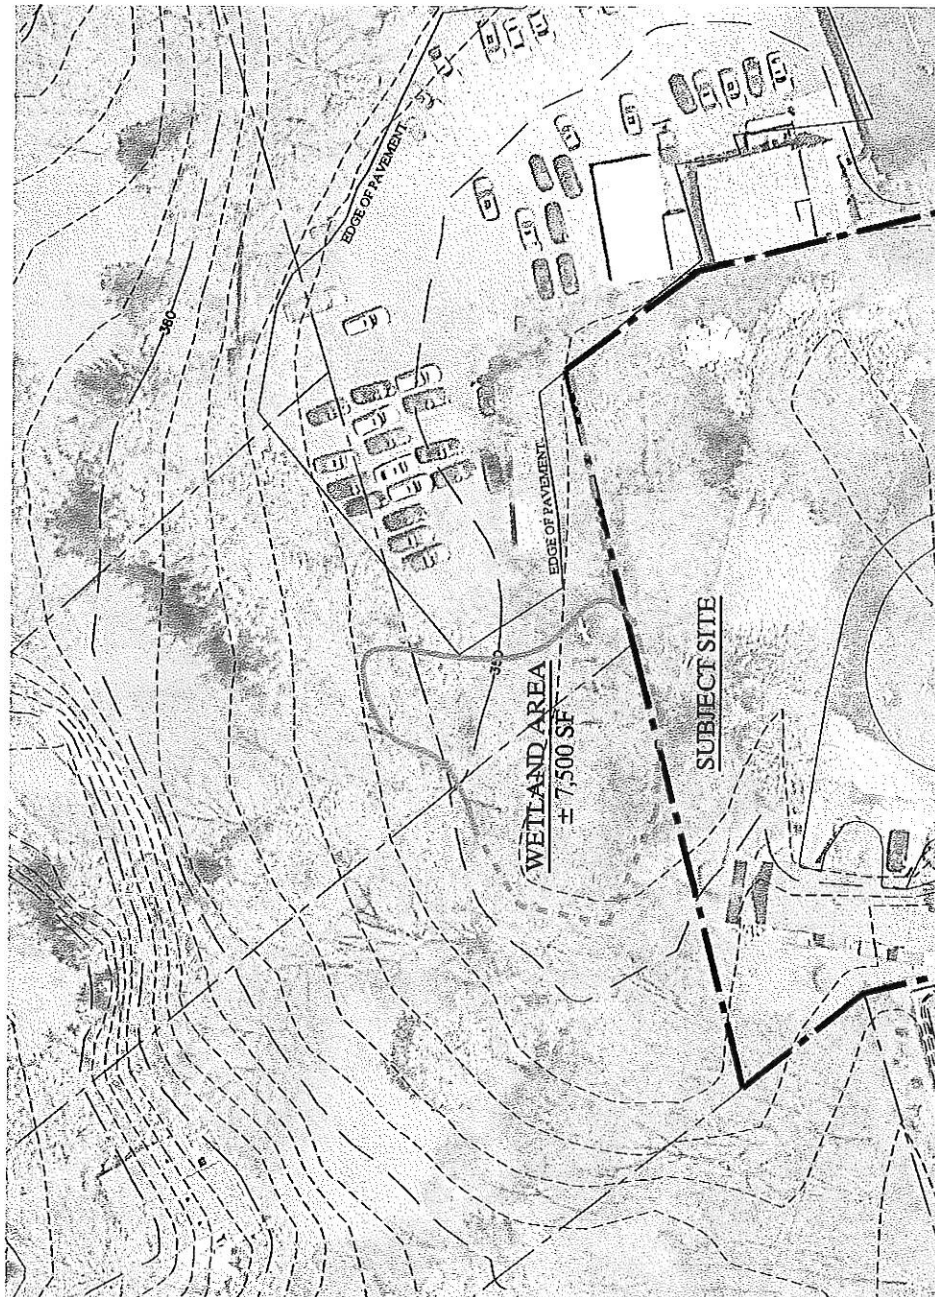
WETLAND LOCATION SKETCH

The forested wetland that is located primarily off-site on the adjoining properties, has been determined to be less than the required size threshold of ½ acre, as per Chapter 105 of the Code of the Town of Ossining. On 05-27-2015, I determined in the field the approximate outer boundary of the off-site wetland. I requested that Dave Sessions, Kellard Sessions, provide a follow up field map that verifies the field determination of the approximate wetland boundary. I have received a follow up "Wetland Location Sketch", dated 06-30-15, as prepared by Kellard Sessions that shows the extent of the wetland

acreage. The size of the wetland is approximately 7,500 square feet, which is under the size threshold, and therefore not considered regulated by the criteria outlined in Chapter 105.
