## MEMORANDUM

RE: 41 & 43 Croton Dam Rd  
Ossining, NY

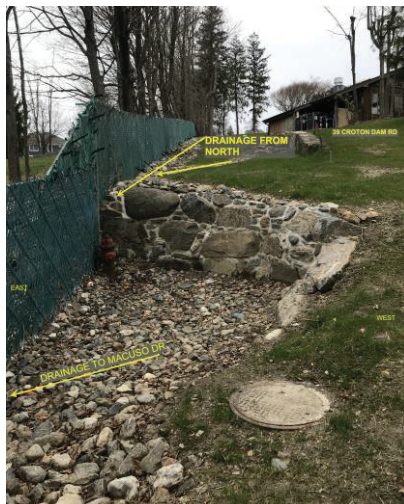
The below left photo shows the current and restored conditions at 39 Croton Dam Rd with drainage flowing to the west. The photo below right shows the existing lawn conditions behind 39 Croton Dam Rd which is uphill from the homes on Cherry Lane. No disturbance and no signs of erosion was observed in this area. Please let us know if you have any questions regarding this matter.
